Company Name	<i>NAVAIR</i> FRC East CP MRO Engineering	Date Submitted	<i>05/24/2021</i>
Project Title	<i>Development of a Mechanical Method of Measurement for the F402 (Harrier) Hot Nozzle (NAV F402)</i>	Planned Starting Semester	<i>Fall 2021</i>

Senior Design Project Description

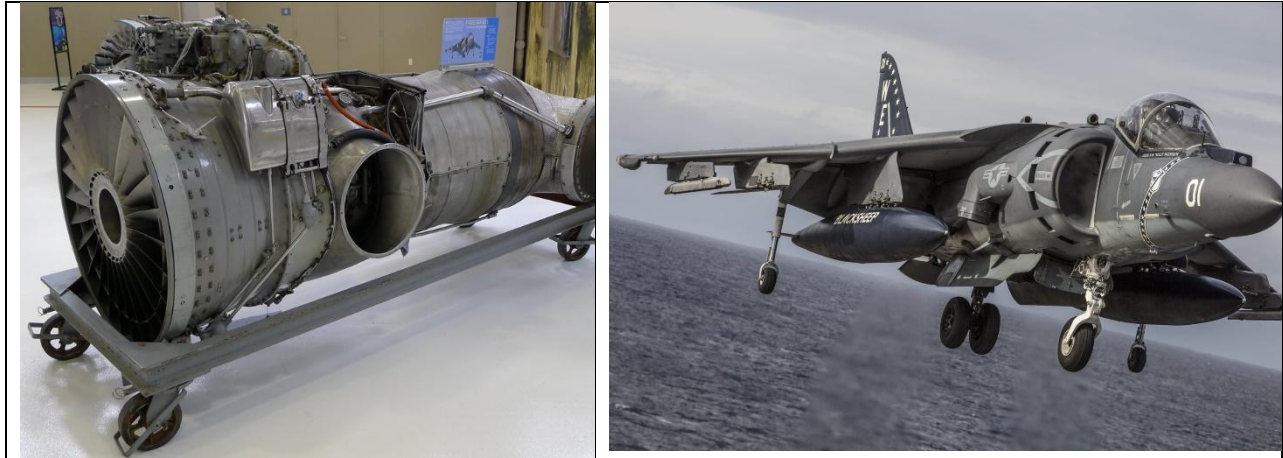
FRC East CP is the Maintenance Repair and Overhaul Facility for the F402 Engine which is used on the AV-8B Harrier Aircraft.

One of the parts of the Engine is the Hot Nozzle, Part Number B510204, which controls the direction of thrust. The proper balance of thrust through the nozzles must be maintained as it is imperative to aircraft operation. The scope of this project is to develop a new method of measurement for the hot nozzle with a working prototype that is generated at the end of the project.

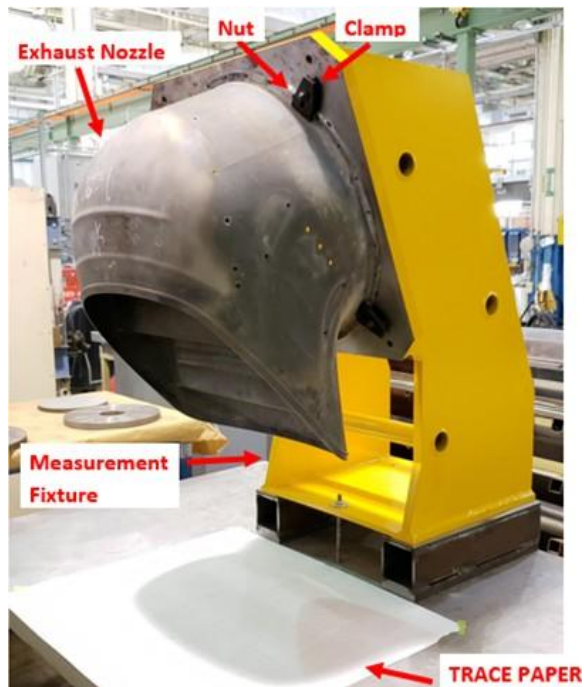
Figure 3: Support Equipment for the Nozzle Trace

The current maintenance process is outlined below. After the nozzle is removed from the Harrier, it is repaired by welding or cold working as needed. It is then mounted to the test equipment below in Figure 3. If there are any trimmers (vanes that can be mounted in the top section of the nozzle to decrease outlet area) in the nozzle, they are removed before the measurement process continues.

After the nozzle has been securely mounted to the stand in Figure 3, the interior of each section is traced using a stylus, Figure 4. The angle of the support equipment may be noted as a feature of interest. The interior vanes of the nozzle are angled at 22 degrees from the horizontal. To accommodate for this angle when tracing, the support equipment must also be angled so that the trace outlines the actual area and not a projected area.

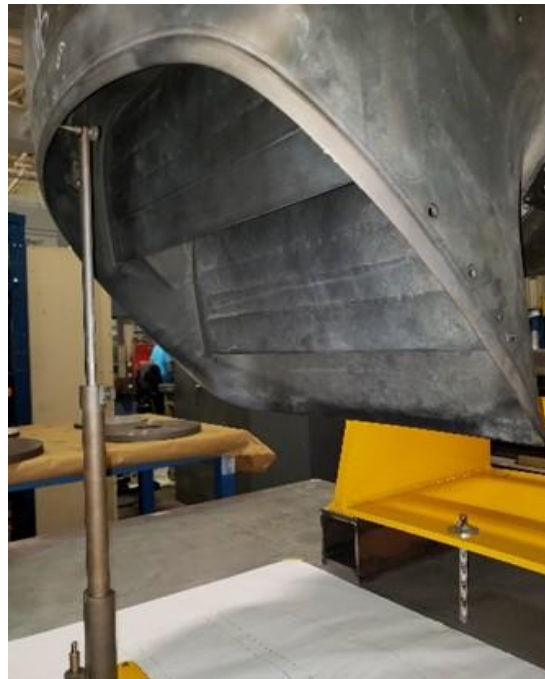
Figure 4: Nozzle and Tracing Stylus

The stylus tip is placed 0.1 inches from the edge of each section at the center of the nozzle. The stylus is then moved around the entire section of the nozzle and a trace of each section is produced. After this, the area is then calculated from the trace via

As the stylus tip is moved around the nozzle, debris on the table has caused the stylus to shift, causing deviations in the trace and resulting measurement. The stylus head also has the potential to be angled. This means the stylus head is not perpendicular to the wall of the nozzle as it is moved around, giving a larger cross-sectional trace than the actual value. Weld seams within the nozzle also cause additional tracing issues. The team has traced one nozzle using the current method; during this process, as the stylus was routed along the nozzle it encountered the weld seams. This led to significant deviations in the cross-sectional area trace, and the stylus trace had to be repeated to obtain a fully developed outline. Per the technical engineering instruction

(TEI), the stylus head should be 0.1 inch from the edge of each section of the nozzle, but this standard is not always followed. When it is followed, establishing and maintaining the 0.1 inch depth is difficult and can lead to error in the trace. Additionally, the stylus is made of metal and the friction created between the metal stylus head and metal nozzle causes chattering in the trace. This in turn equates to error in the measurement trace and overall measurement.
